**Vegetation monitoring: Pipeline servitude
rehabilitation between Temane and the border at
Ressano Garcia/Komatipoort**

Monitoring report

Prepared to: Sasol

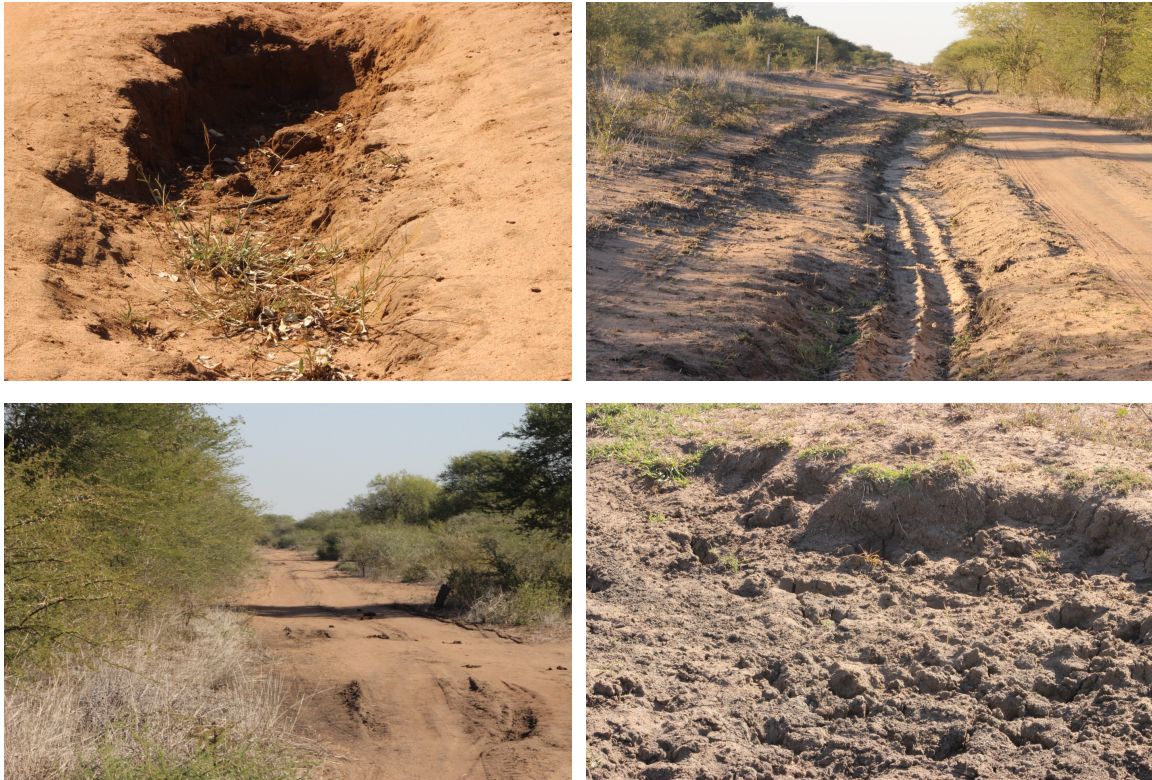
Figure 4 – Evident erosion signs along the pipeline

Figure 4 present some photographic examples of erosion and Figure 5 represents the evident erosion signs or that can lead to erosion locations along the pipeline.

During field work evident erosion signs were recorded at 68 different locations, mainly located at the south part of the pipeline, were it seems to be a problem. Several situations seemed to occur due to water runoff, in a places that, prior to pipeline construction, should function as small streams. All situation seems to be normal for a post rainy season period, when heavy rain fall causes normal damages on dirt roads, and in some places it was possible to see small channels resulting intermittent water downstream precipitation. Documented situations occurred exclusively in sloping sites of the ROW in Magude, Chokwé and Ressano García districts, and no signs of erosion were seen in adjacent areas.

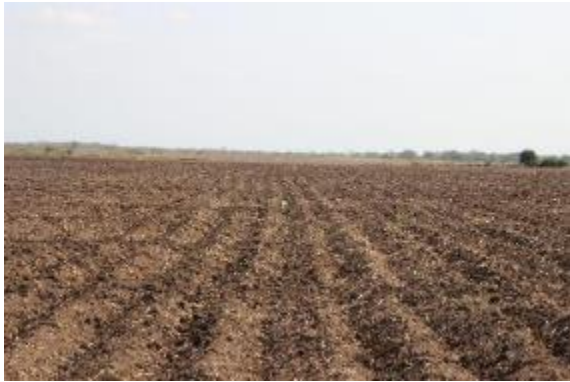
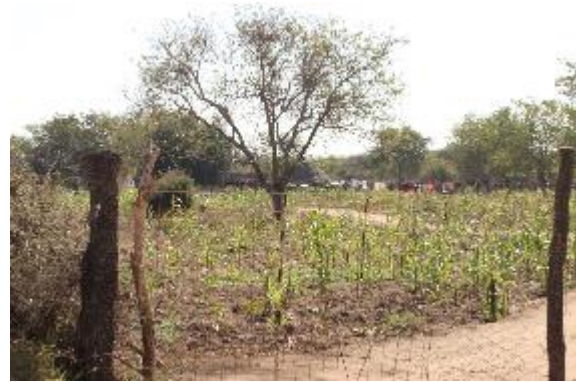
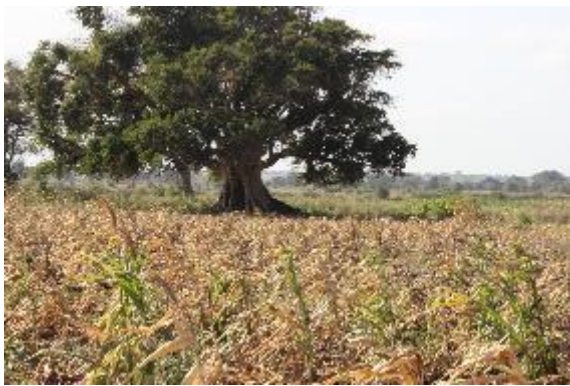
Figure 6 – Agriculture along the pipeline

Although there are large agricultural areas, most agriculture along the pipeline seem to be of small dimension (machambas) and for own consumption. Cultivated products are traditional in Mozambique, such as maize, cassava, peanuts and pumpkin (Figure 6).

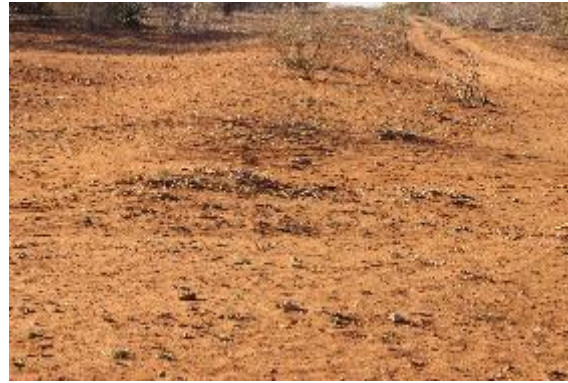
Figure 8 –Bare patches along the pipeline

The number of bare patches was low, only 19, and no fire signals were observed (FIGURE 8 and FIGURE 9). As so, these situations can result from soil characteristics (e.g. degree of sieving, the topsoil slope quantity of rock in the substrate, water availability); soil compaction that leads to the vegetation has more difficulty in establishing; or disturbances caused by human activities. By analyzing the data with other disturbances identified, sign of relation was found. Evident signs of erosion were not observed in any of the recorded situations (FIGURE 8).

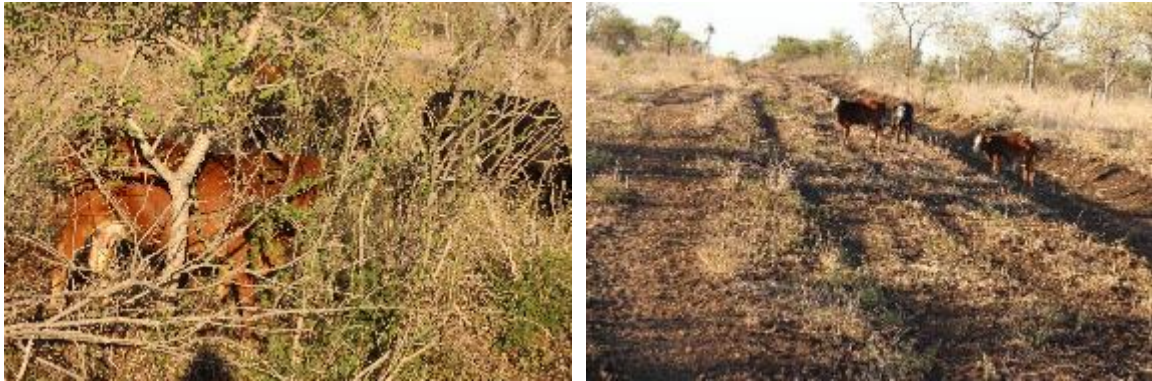
Figure 10 – Cattle observations along the pipeline

The use of the ROW by cattle was documented in the previous monitoring results, and, according to 2016 data (**Figure 10** and FIGURE 11), it continues to grow. With the higher number of settlements an increase in livestock is naturally expected. Even so, bare patches were not common across the ROW and vegetation of the pipeline area is in a good condition (Plan B), so, for now it seems that cattle does affects the growth of vegetation.

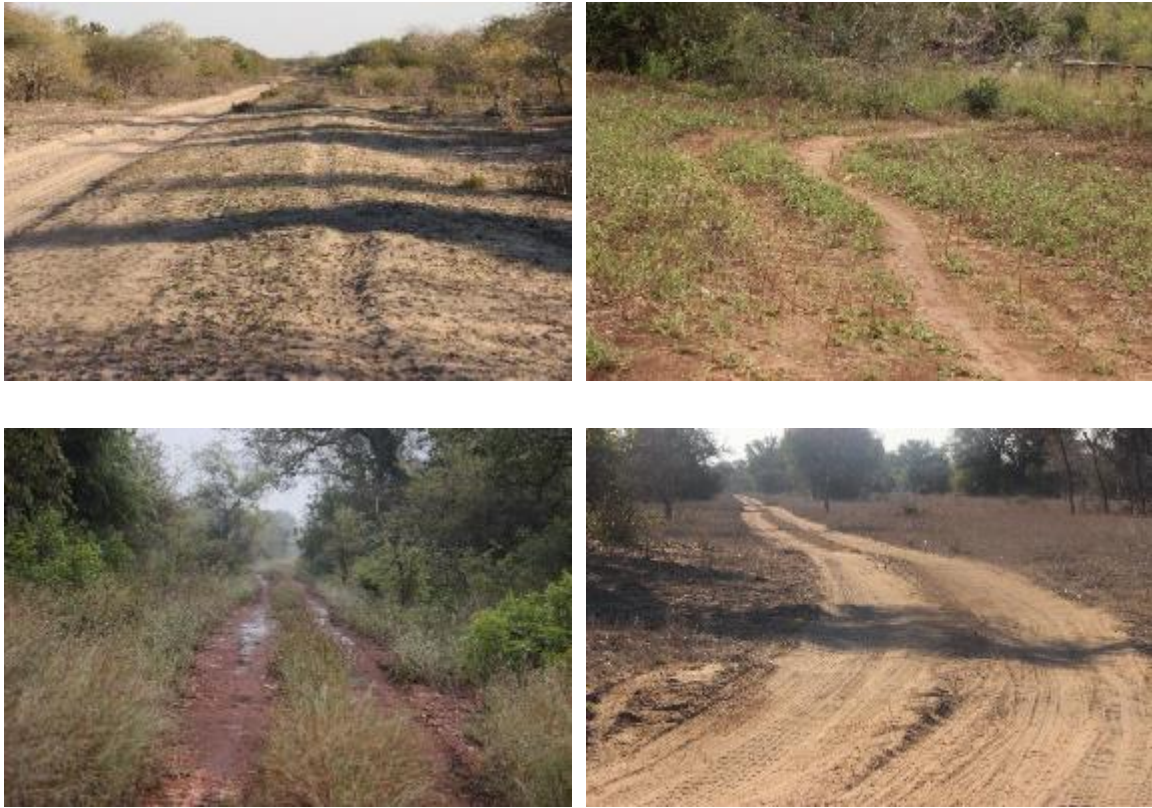
Figure 12 – Different roads and paths along the pipeline

Since the beginning of the project the number of roads and paths along the pipeline has increase greatly. Nowadays there are 191 roads and paths that cross the pipeline Right of Way. Some of the paths seen are probably cattle paths, and may be used by local population (Figure 12). The ROW itself is also used by vehicles that are not SASOL service vehicles, which is used to access major roads that depart from it (Figure 12 and Figure 13). As so, it is considered that the use of the ROW as well as the crossing roads and paths by locals is well-establish (Figure 14).

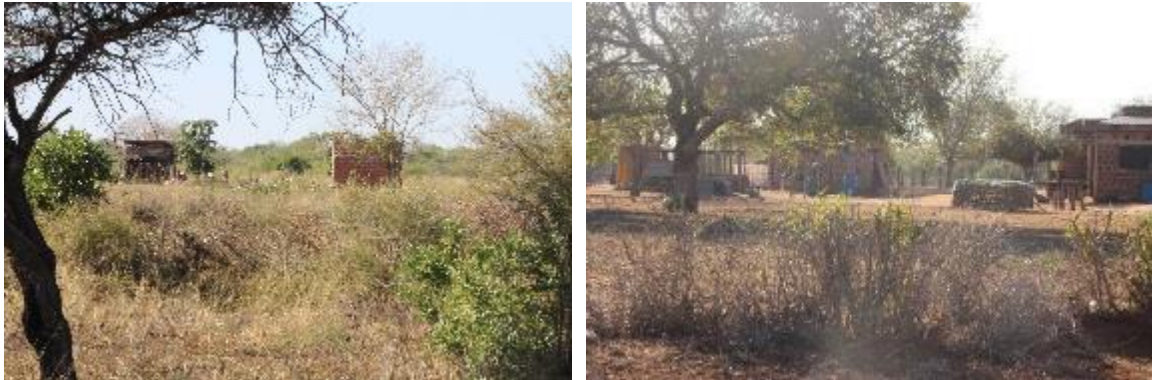
Figure 15 – Villages and settlements along the pipeline

The number of settlements and villages along the pipeline seems to be persistent, with no signs of new establishments (Figure 15 and Figure 16). Even so, there are no data regarding the number of houses and population in these locations, so human presence may be increasing throughout the pipeline.

Settlements and villages are related with agricultural areas (machambas) which seems to indicate that these are not temporary settlements.

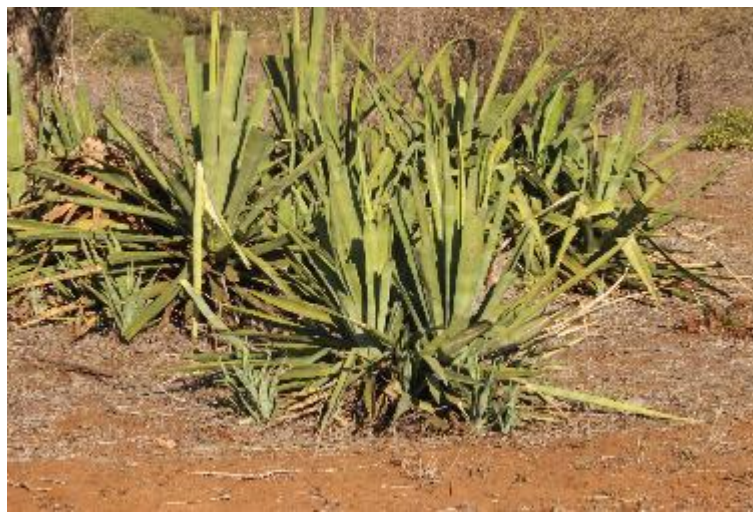
Figure 18 – *Agave sisalana* present along the pipeline

In previous years only 6 invasive species were identified: *Agave sisalana* (Figure 18), *Opuntia ficus-indica*, *Opuntia monacantha*, *Lantana camara*, *Ricinus communis* (FIGURE 27) and *Xanthium strumarium* (FIGURE 29).

Specie	Control Method/ Recommendations
<i>Agave sisalana</i>	Cut of the central growth stem as low as possible and herbicide solution application immediately after cutting (within 20 s).
<i>Argemone mexicana</i>	Hand weeding. It should be carried out before the plant has set seed.
<i>Azolla pinnata</i>	Manual removal by using thin-meshed nets. It is the preferred methodology when the invaded areas are relatively small. All material should be removed from the location, as this plant reproduces vegetatively through fragments of stems that root easily
<i>Caesalpinia decapetala</i>	Seedlings and saplings can be dug up or pulled up manually. Larger plants must be cut and stumps treated with herbicide.
<i>Cereus jamacaru</i>	Single, isolated seedlings should be uprooted and placed onto a place where they will be unable to set roots again. Care must be taken that no part of the plant is left lying where it can root. Under no circumstances must pieces of the plant simply be carted away to be discarded, since this is one of the most common ways in which cactus infestations originate

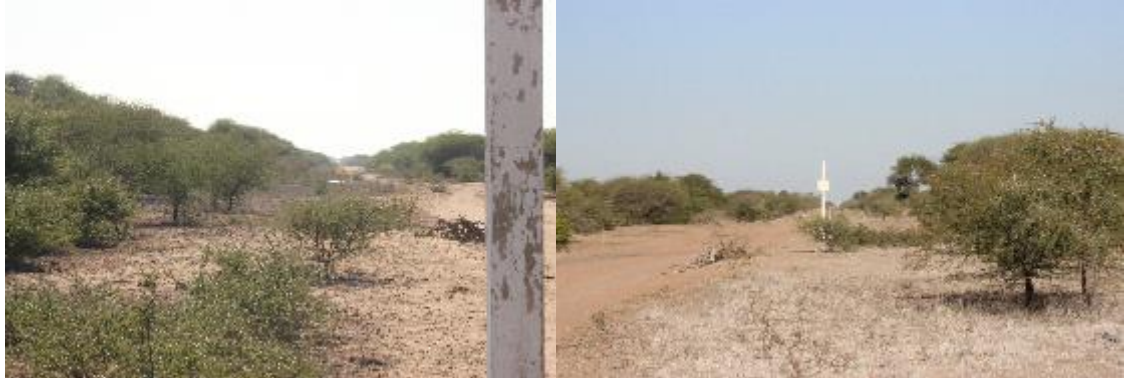
3.5

There are some differences between pair of plots, especially in plot 3.5. In this location bare soil in the pipeline plot is 85%, which is much higher than in the control plot, where it reaches 50% (Figure 33).

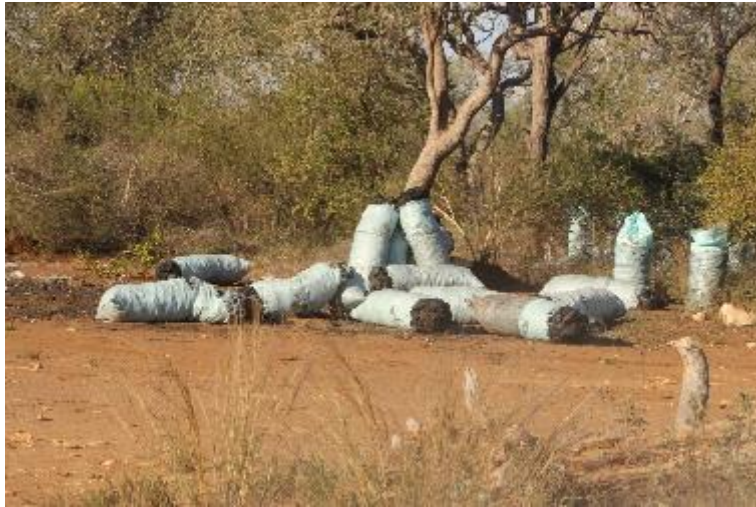
FIGURE 40 – CHARCOAL BAGS PILED UP ALONG THE PIPELINE

According to Deacon (2012), natural resources exploitation seemed to be decreasing in 2011, compared to the situation observed in 2008 and 2009 (Table 18). In 2016, charcoal exploitation appears to have increased, while the use of wood cutting and continues to decrease. However, this data should be analyzed carefully as the collected information is a small sample of the reality, since it only reflects the situations observed in only one pass through the project area, providing a picture of a given time. Thus, small variations in the observed numbers may not reflect the reality of the situation, since they are the reflection of the activities that were being carried out on a certain day at a certain place. It should also be noted that this monitoring only contemplates pipeline servitude and no data on what happens around the project has been registered. Thus, the situation on surrounding area is unknown, such as impacts in areas that are now accessible from the ROW and/or the new existing paths and roads linked with the ROW.

- Perform studies to assess the extension of natural resources exploitation in the surrounding area, to confirm which are the most affected areas and species, establishing the baseline situation nowadays and accessing the expected evolution;
- Only after that characterization will be possible to assess the real impact and define the most adjusted measures to mitigate those impacts. One possibility may be the plantation of the most affected species in specific areas, in order to offset the losses caused by increased accessibilities. However, only with the suprarrefered specific studies will be possible to propose additional mitigation measures.
