Wildlife use of existing culverts and bridges in North Central Pennsylvania

Carl O. Brudin
Marble & Company

Brudin CO. 2004. Wildlife use of existing culverts and bridges in North Central Pennsylvania. IN: Proceedings of the 2003 International Conference on Ecology and Transportation, Eds. Irwin CL, Garrett P, McDermott KP. Center for Transportation and the Environment, North Carolina State University, Raleigh, NC: pp. 344-352.

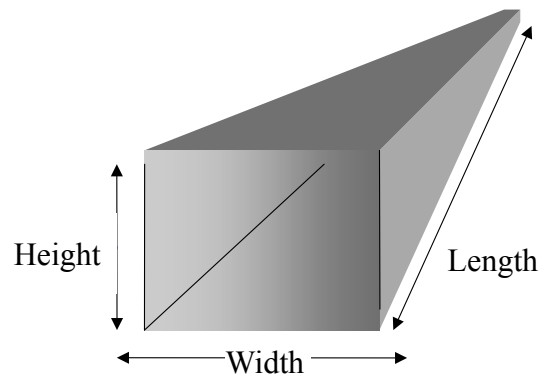
Fig. 2. R/C Box Culvert Dimensions.

(Height x Width) Divided by Length = OI (Openness Index)
Example (6ft. x 8ft.) / 150ft. = 0.32 OI

The width and height of the underpass opening, as well as the underpass length, are important factors in determining the type and size of animals that can use the underpass. These measurements are used to calculate an openness index (OI) (width x height/length) (see figure 2). The openness of an underpass influences the amount of light that penetrates the interior and the view of the other side. For example, an 80-foot long, 10-foot wide and 8-foot high box culvert has an OI = 1.0. Doubling the width or height to 20 feet, increases the OI to 2.0. Length, width and height of underpasses, and other factors including its “openness,” can greatly influence animal use. The Openness Index number, however, does not differentiate between height and width, and special attention should be made to species’ tolerance for recommended heights and widths.
