**Vegetation monitoring: Pipeline servitude
rehabilitation between Temane and the border at
Ressano Garcia/Komatipoort**

Monitoring report

Prepared to: Sasol

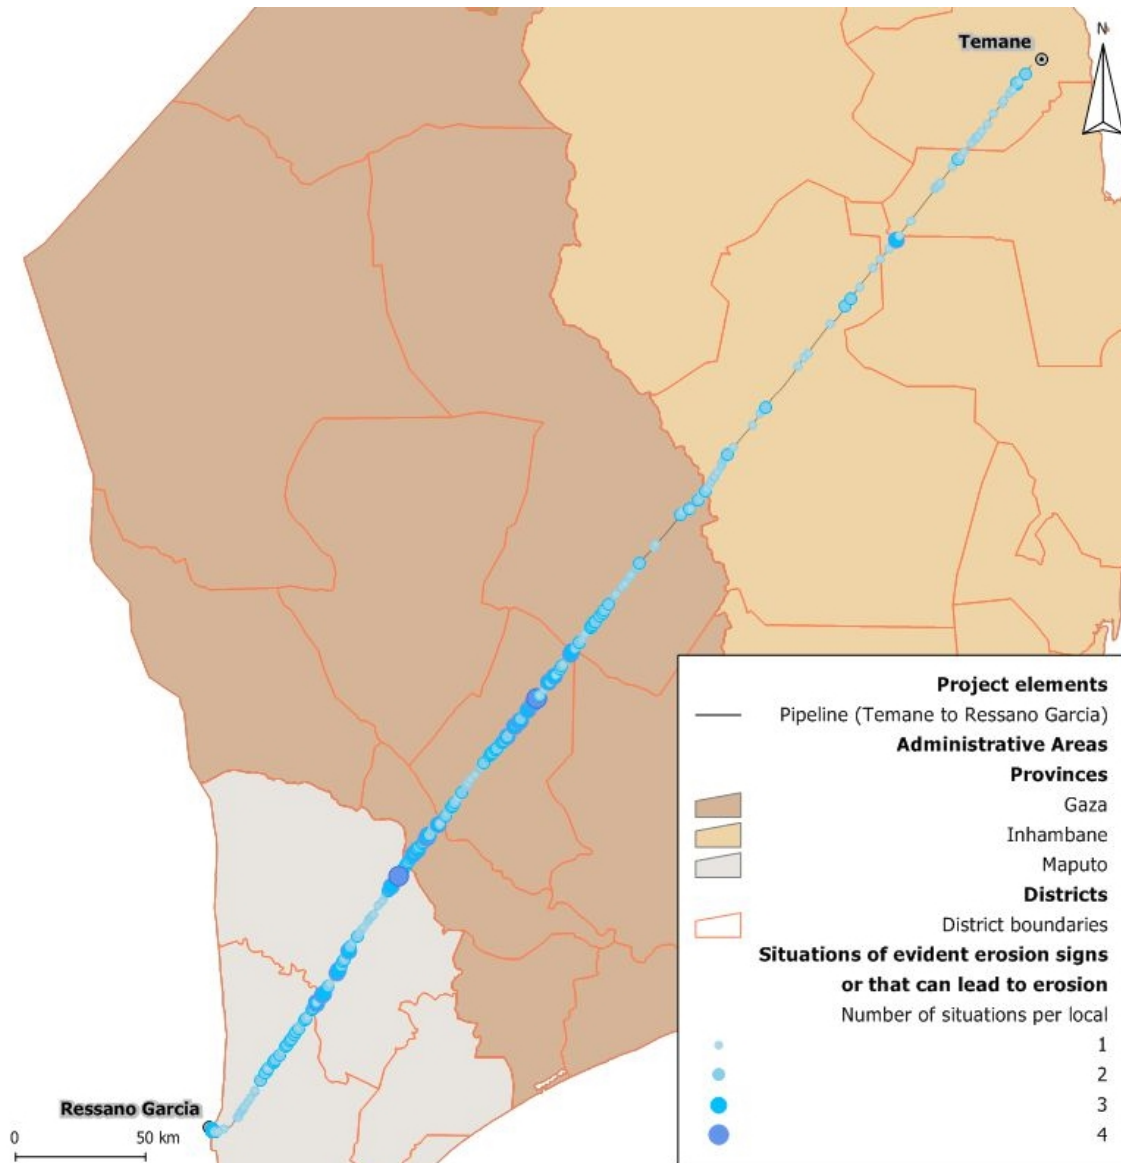
Figure 3 – Location of different situations of evident erosion signs or that can lead to erosion

By analyzing Figure 7 it is clear that most situations of erosion, or that can let to erosion, occur in the south area of the pipeline. In the North area, mainly on Inhambane Province, the number of erosion problems locations are clearly lower than in Gaza and Maputo Provinces.

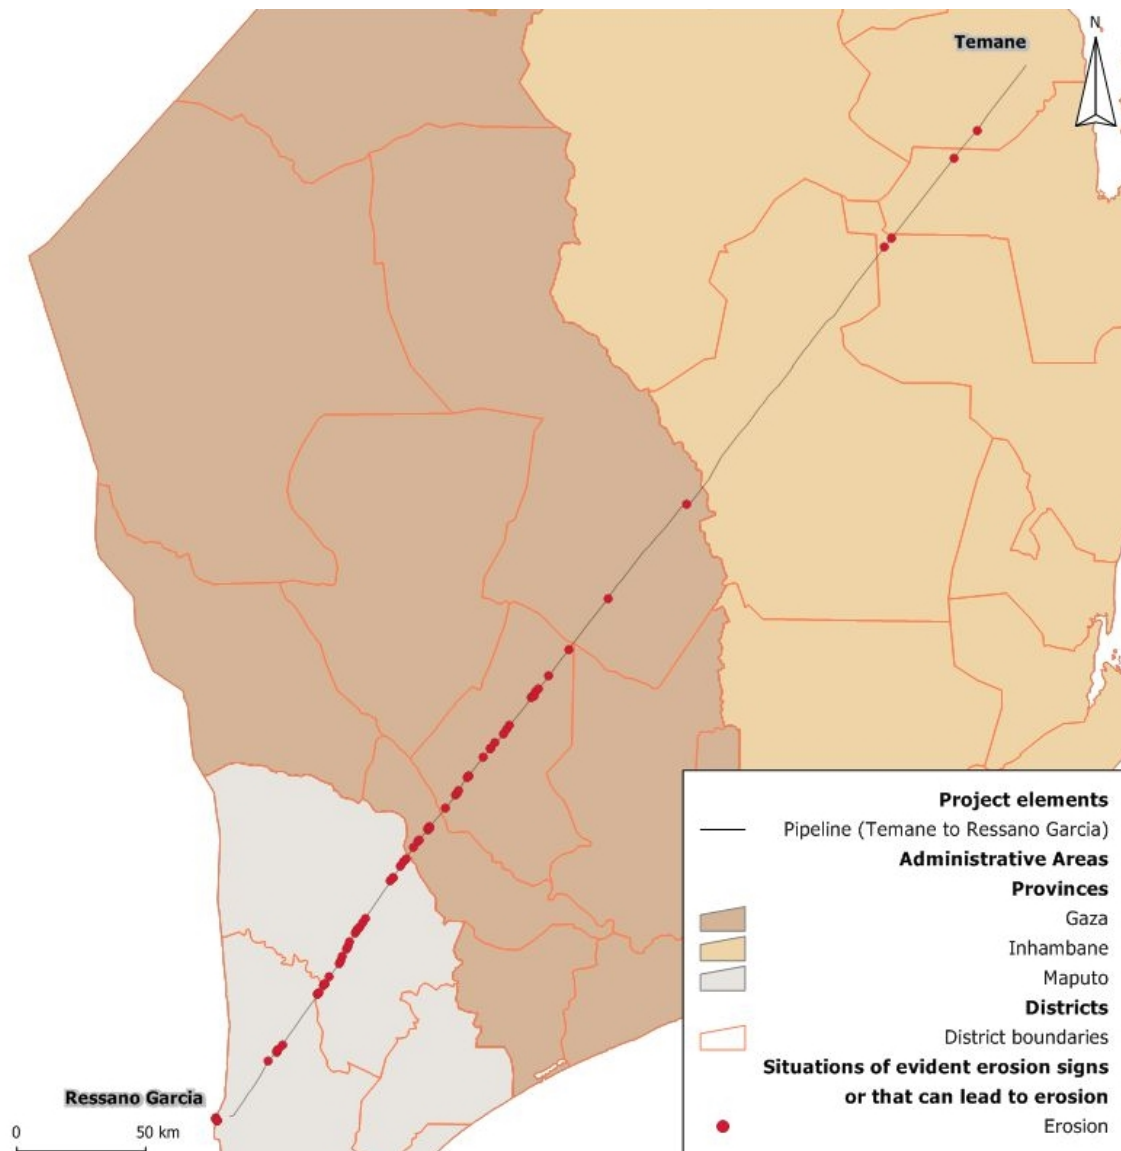
Figure 5 – Location of evident erosion signs along the pipeline

During field work evident erosion signs were recorded at 68 different locations, mainly located at the south part of the pipeline, were it seems to be a problem. Several situations seemed to occur due to water runoff, in a places that, prior to pipeline construction, should function as small streams. All situation seems to be normal for a post rainy season period, when heavy rain fall causes normal damages on dirt roads, and in some places it was possible to see small channels resulting intermittent water downstream precipitation. Documented situations occurred exclusively in sloping sites of the ROW in Magude, Chokwé and Ressano García districts, and no signs of erosion were seen in adjacent areas.

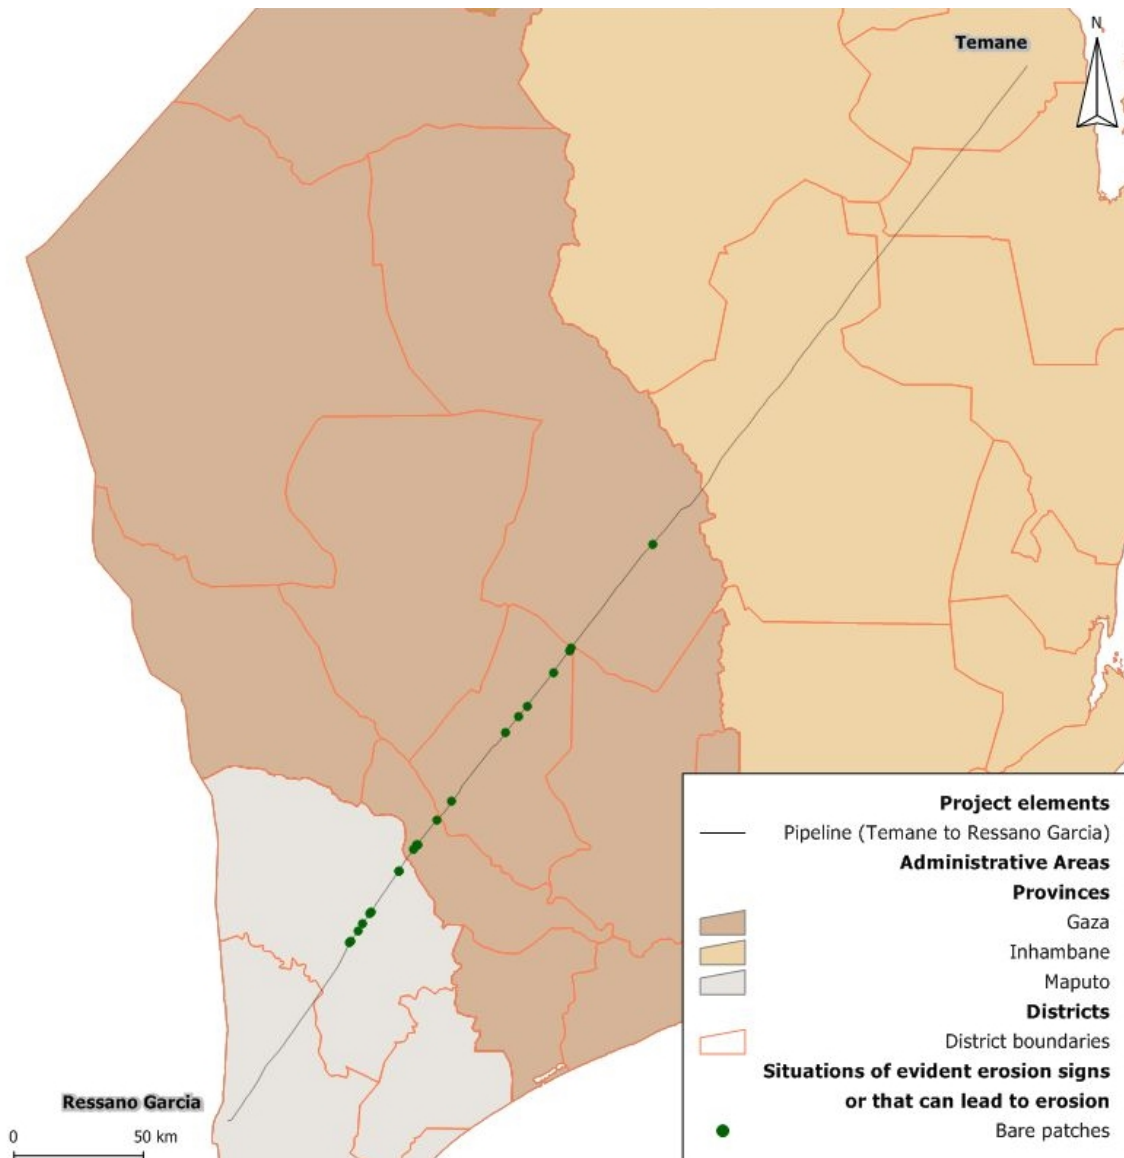
Figure 9 – Location of different Bare patches

The number of bare patches was low, only 19, and no fire signals were observed (FIGURE 8 and FIGURE 9). As so, these situations can result from soil characteristics (e.g. degree of sieving, the topsoil slope quantity of rock in the substrate, water availability); soil compaction that leads to the vegetation has more difficulty in establishing; or disturbances caused by human activities. By analyzing the data with other disturbances identified, sign of relation was found. Evident signs of erosion were not observed in any of the recorded situations (FIGURE 8).

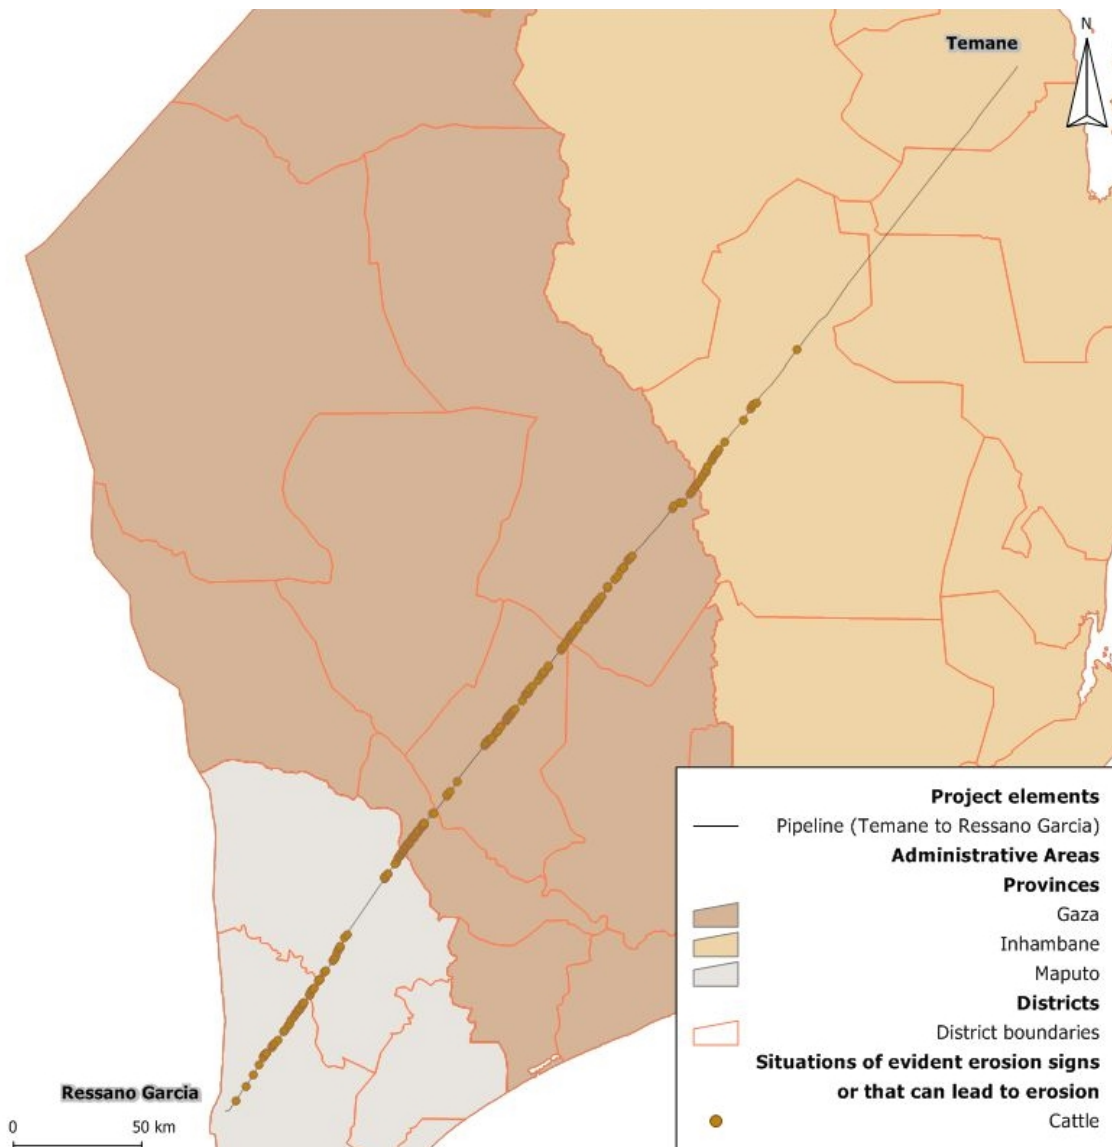
Figure 11 – Location of cattle observations

The use of the ROW by cattle was documented in the previous monitoring results, and, according to 2016 data (**Figure 10** and FIGURE 11), it continues to grow. With the higher number of settlements an increase in livestock is naturally expected. Even so, bare patches were not common across the ROW and vegetation of the pipeline area is in a good condition (Plan B), so, for now it seems that cattle does affects the growth of vegetation.

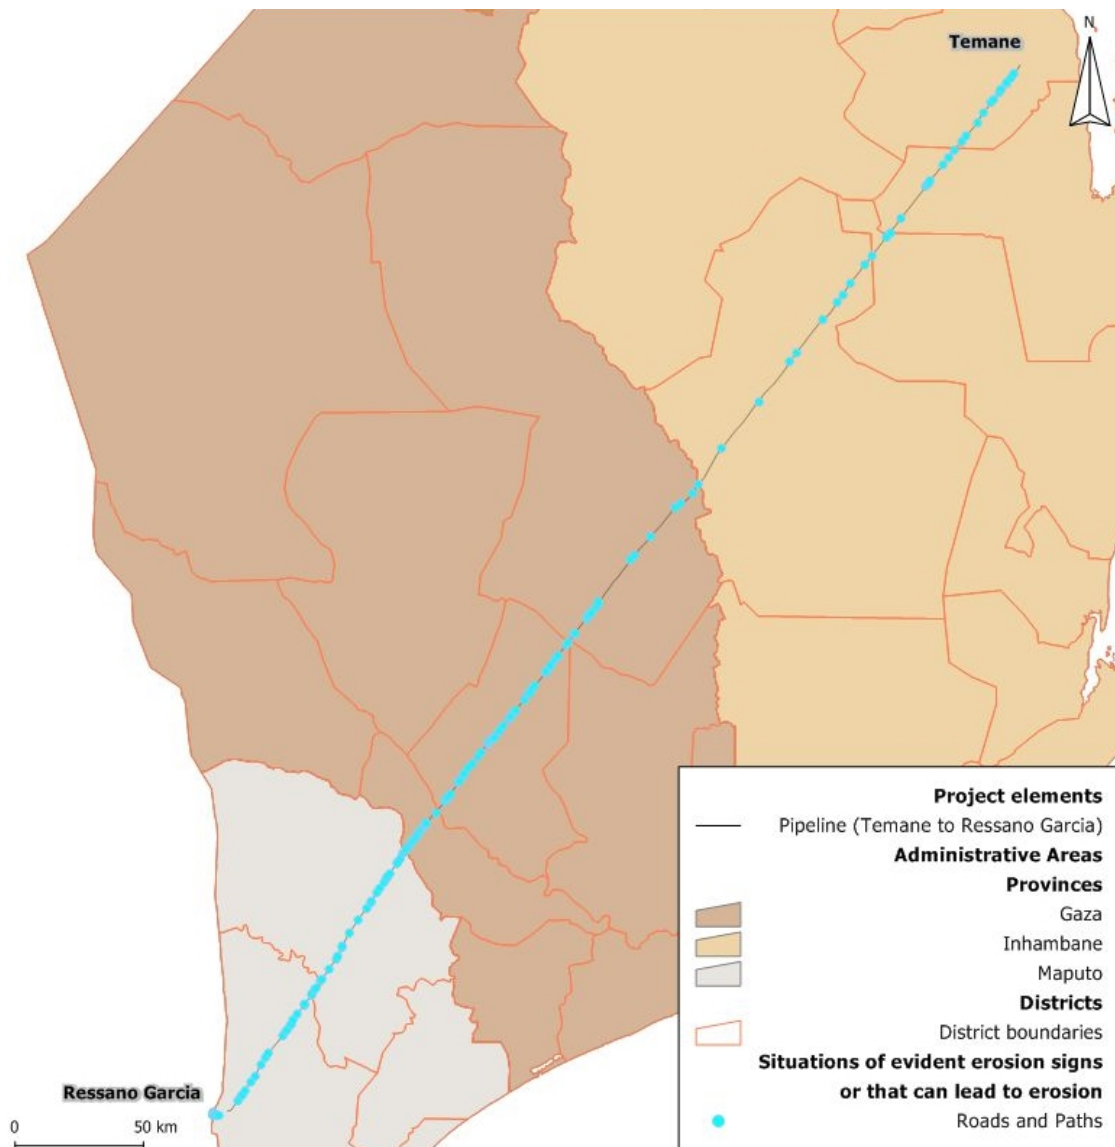
Figure 14 – Location of different roads and paths along the pipeline

Since the beginning of the project the number of roads and paths along the pipeline has increase greatly. Nowadays there are 191 roads and paths that cross the pipeline Right of Way. Some of the paths seen are probably cattle paths, and may be used by local population (Figure 12). The ROW itself is also used by vehicles that are not SASOL service vehicles, which is used to access major roads that depart from it (Figure 12 and Figure 13). As so, it is considered that the use of the ROW as well as the crossing roads and paths by locals is well-establish (Figure 14).

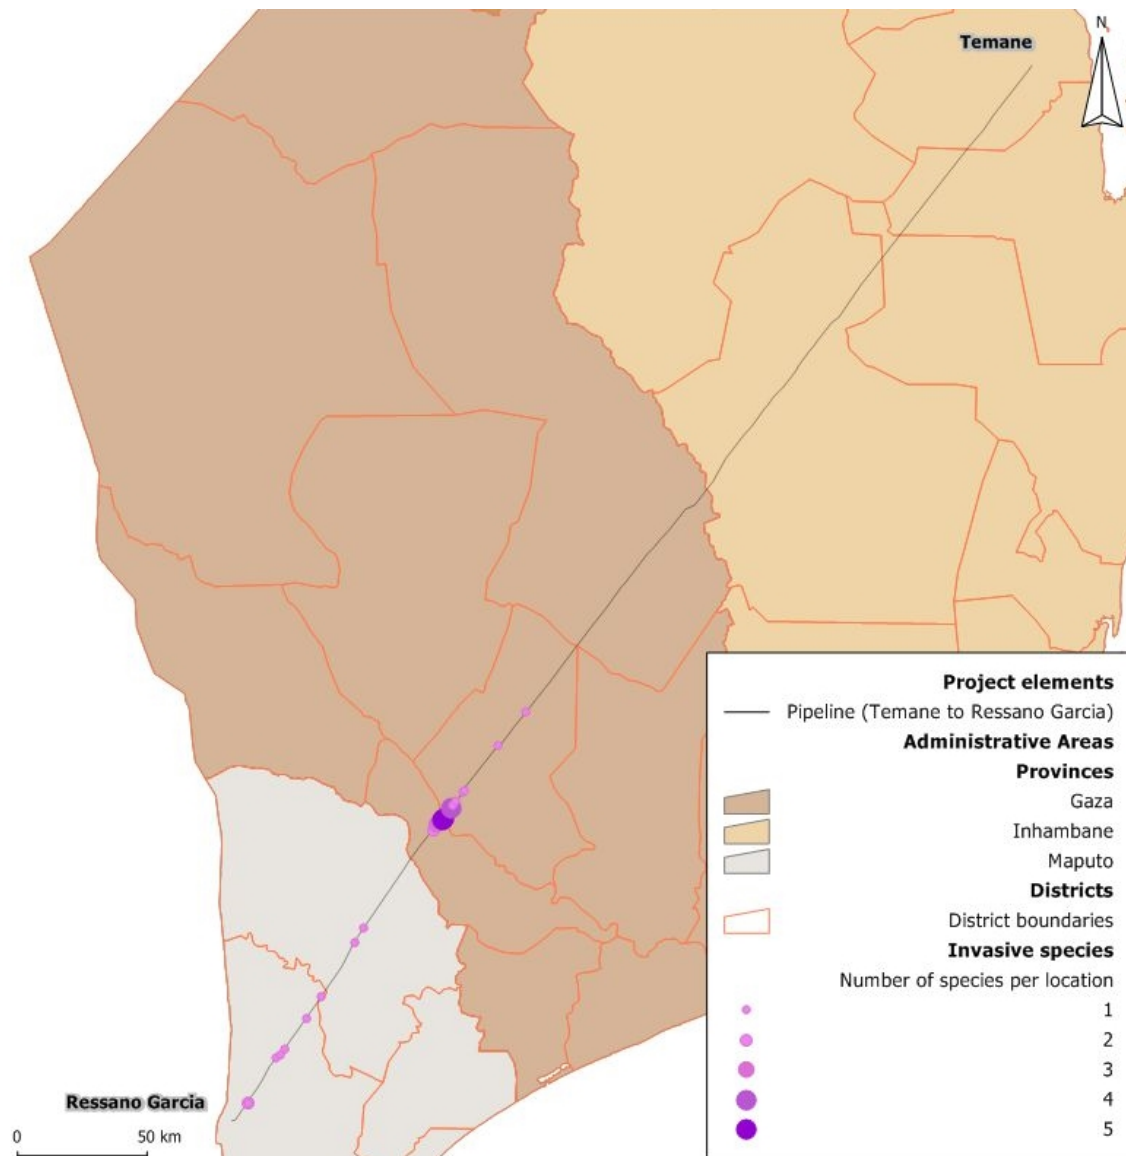
Figure 17 – Location of invasive plant species along the pipeline

Regarding invasive alien species, there were 12 different plant species identified along the pipeline ROW. Invasive species were seen in 26 different locations, with one to five different species in each one (Table 4). They are mainly present in the Gaza province, from the Guijá district to the south (Figure 17).

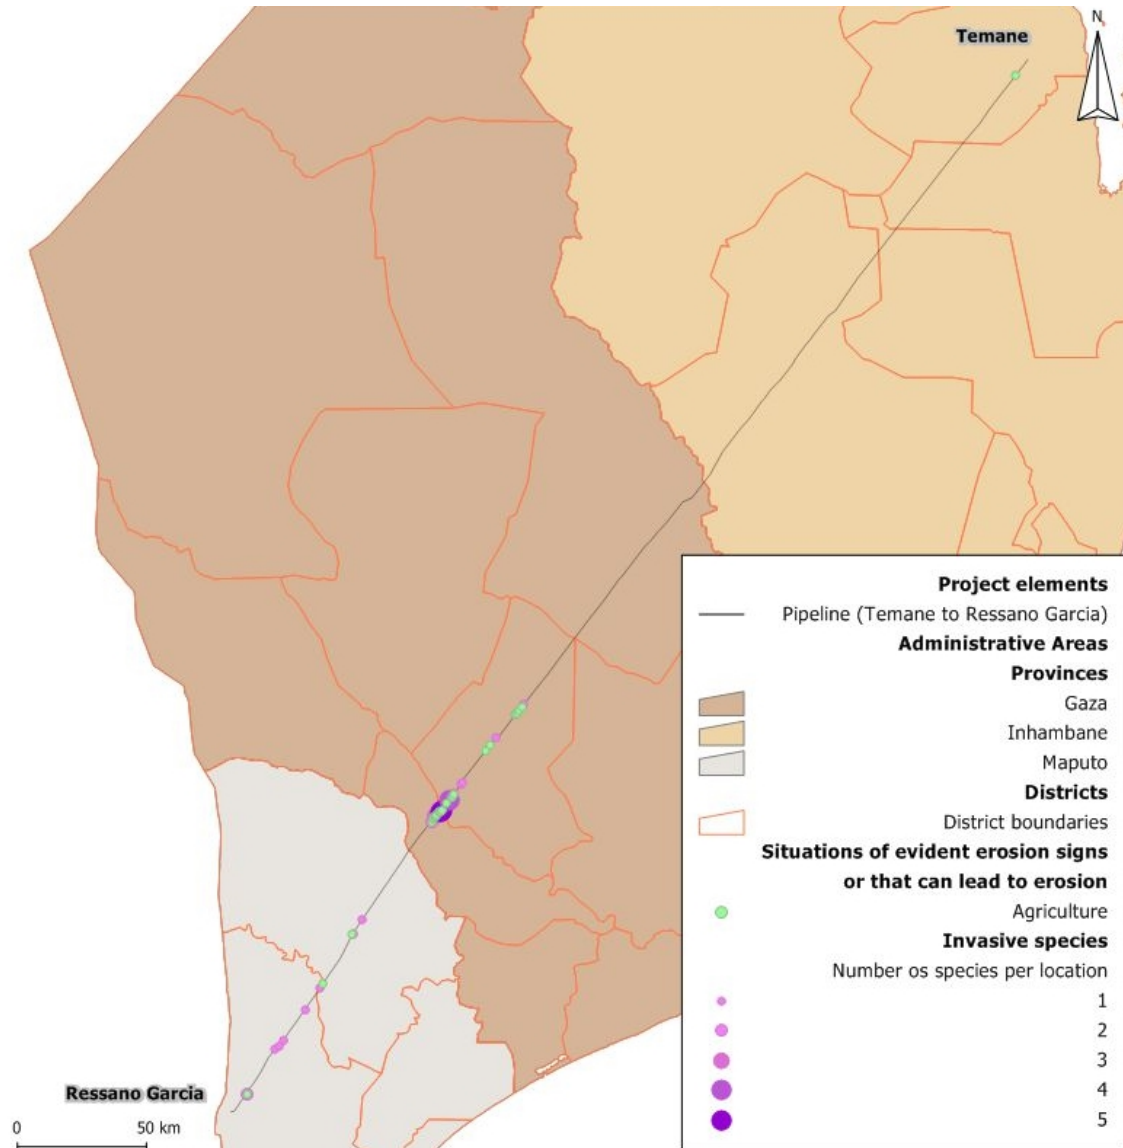
Figure 30 - Comparing the location of agricultural areas and invasive plant

Comparing locations of evident erosion signs and of unauthorized activities over the pipeline servitude no evident correlations has been found. Even so, the presence of invasive plant species seems to be correlated with the presence of Agricultural sites (Figure 30).

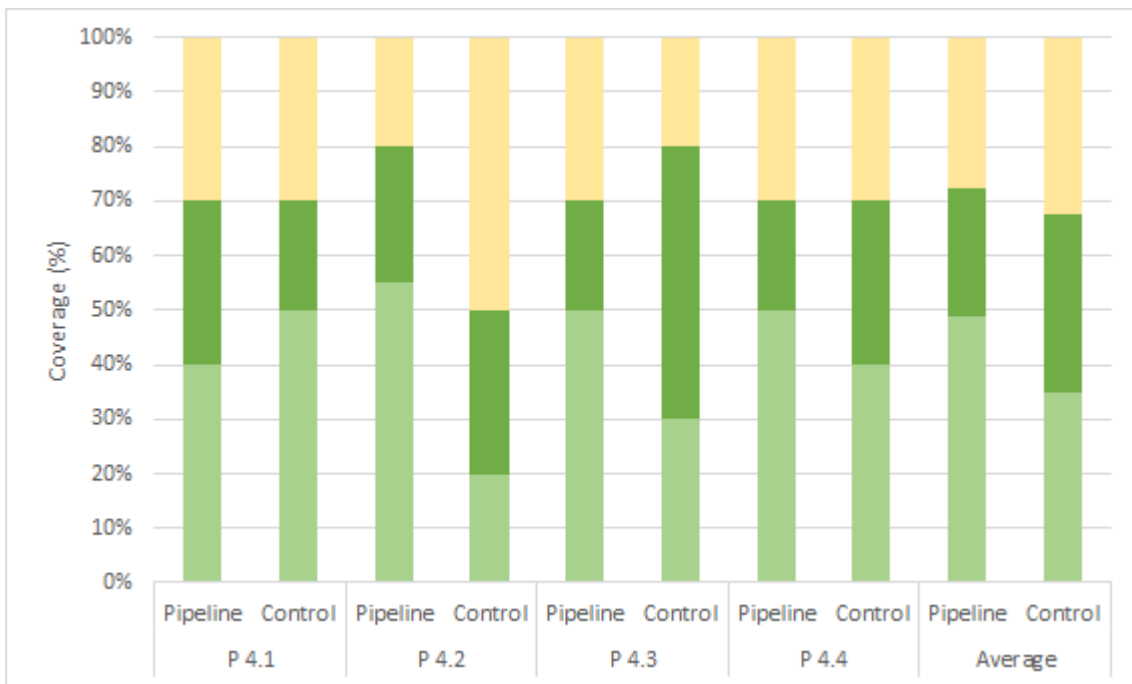
FIGURE 34 - SOIL COVERAGE (IN PERCENTAGE) IN THE 4 MONITORING PLOTS IN SITE 4. ■ HERBS, ■ SCRUBS, ■ BARE SOIL.

In site 4 a total of 32 different plants species were identified during field work. The exploratory analyses of the coverage percentage of herbs, scrubs and bare soil shows that, in general, pairs of plots are very alike (Figure 34). In average herb and scrub coverage differ slightly in pipeline and control plot, but bare soil coverage is very similar: 28% in pipeline plots and 33% in control plots. As so, in average vegetation coverage in pipeline area is higher than in control areas (Figure 34). Nevertheless, there are some plots where the differences are more evident, as plots 4.2. In this plots bare soil coverage is much higher in control area, reaching 50%, than in the pipeline plot, where it reaches only 20%.

The statics result from PERMANOVA, in which the factor “location” (pipeline vs control) was imposed, indicates that there are no significant differences between pipeline and control plots, since the p-value obtained is 0,1472 ($p(\text{perm})=0,1472 > 0,05$). As so, vegetation in the two different type of plots, concerning herb and scrub species composition, is similar. Since construction activities Since the construction of the existing MSP occurred to some time ago and the construction activities did not begun yet in this site these results were expected. Even so, there are other disturbances in the area that can affect the growth of vegetation, such as the presence of cattle. According to this results, vegetation on pipeline area is able to evolve, despite these other disturbances.

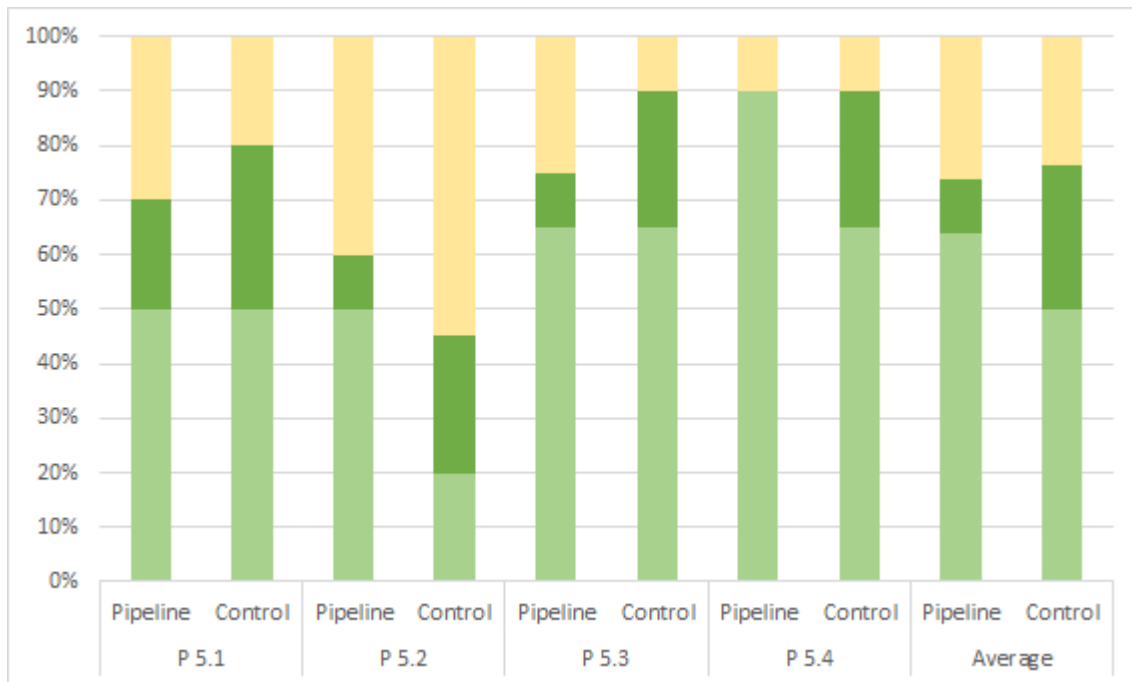
FIGURE 35 - SOIL COVERAGE (IN PERCENTAGE) IN THE 5 MONITORING PLOTS IN SITE 5. ■ HERBS, ■ SCRUBS, ■ BARE SOIL.

Sampling of site 5 allowed the identification of 36 plant species. By analyzing the coverage percentage of herbs, scrubs and bare soil (Figure 35Figure 31) it can be seen that in average pipeline and control plots have similar vegetation coverage, although in control plots scrubs represent a higher percentage than in pipeline plots. Looking at each one of the plot major differences can be seen between plots 5.2, where the control area has more than 50% of bare soil, whereas the pipeline bare soil coverage is 40%. Another situation that stands out is the pipeline area of 5.4 plot, where shrub species were not observed. These species represent 25% of the control area of sampled in plot 5.4 (Figure 35).

The p-value obtained ($p(\text{perm}) = 0,028 > 0,05$) shows that there are significant differences between the floristic communities in pipeline and control plots. As so the plots are not similar regarding their herb and scrub composition.

Although sites where the project is in full construction were excluded from the analysis, these findings are not surprising, since construction has been initiated in some locations. Higher movement of heavy machinery and personnel and initial construction activities may already operate changes upon pipeline plots.

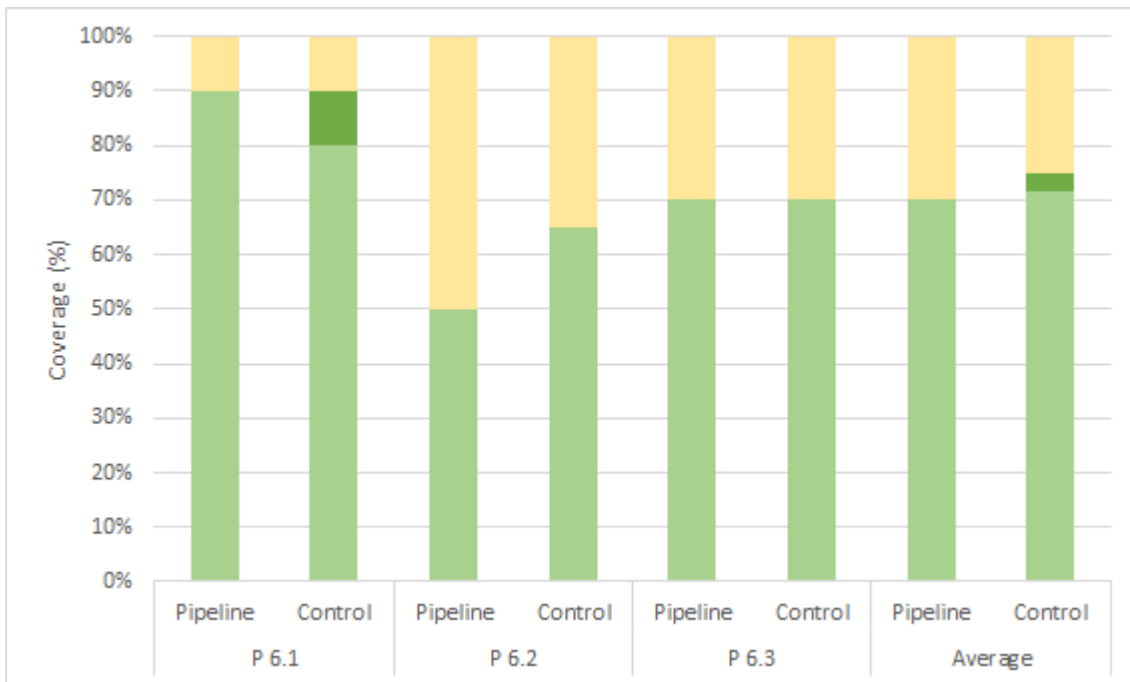
FIGURE 36 - SOIL COVERAGE (IN PERCENTAGE) IN THE 3 MONITORING PLOTS IN SITE 6. ■ HERBS, ■ SCRUBS, ■ BARE SOIL.

In this site all the plots were successfully sampled during the field work and a total of 27 plants were identified. On the coverage percentage of herbs, scrubs and bare soil all plots are very similar, and scrubby vegetation was only present in the control plot of site 6.1 (Figure 36 and Figure 31). In average, pipeline and control sites are look alike, with bare soil coverage of 30 and 25% each.

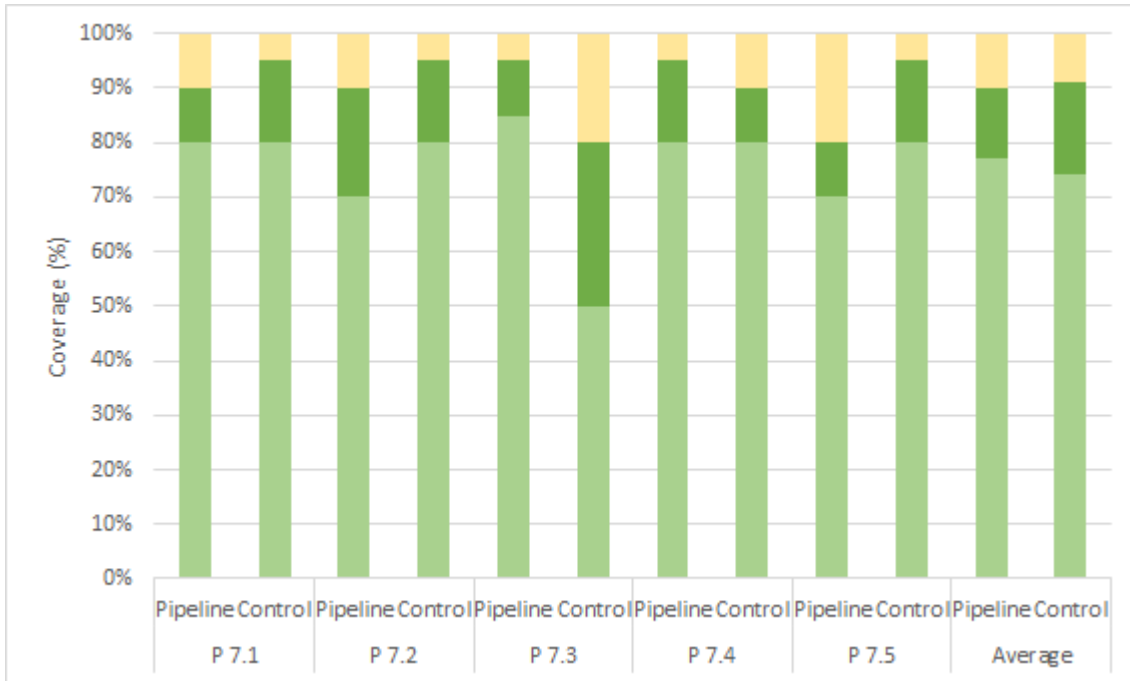
FIGURE 37 - SOIL COVERAGE (IN PERCENTAGE) IN THE 5 MONITORING PLOTS IN SITE 7. ■ HERBS, ■ SCRUBS, ■ BARE SOIL.

In site 7 a total of 32 different plants species were identified during field work. The exploratory analyses of the coverage percentage of herbs, scrubs and bare soil shows that, in general, pairs of plots are very look alike (Figure 37 and Figure 34). The average values for pipeline and control plots are very similar, as total vegetation (herbs and scrubs) covers 90% in pipeline plots and 91% in control plots.

The statics result from PERMANOVA, in which the factor “location” (pipeline vs control) was imposed, indicates that there are significant differences between plots located in the pipeline area and plots located at control areas ($p(\text{perm})=0,0169 > 0,05$). As so, although coverage percentage of herb and scrub seem to be similar, vegetation in the two different type of plots is different regarding the herb and scrub species composition, although construction activities have not begun.

As so, according to our results, sites are similar respecting coverage percentage of herbs, scrubs and bare soil, but different in respect of the species that area present in each type of plots. Differences between pipeline and control vegetation in this site may be explained by disturbances not related to the project. According to previous works done in the area, the sites are regularly burned by local people during the spring, what might influence grass cover rehabilitation (Deacon, 2012) and species composition. Other important fact is that vegetation on control area has a great percentage of trees. Shading effect of high tree cover on control plots can also affect species composition, constraining the grown of sunlight depending herbs, which does not occur in pipeline plots. As so, in sites were the control plots area mainly occupied by trees these differences are expectable.

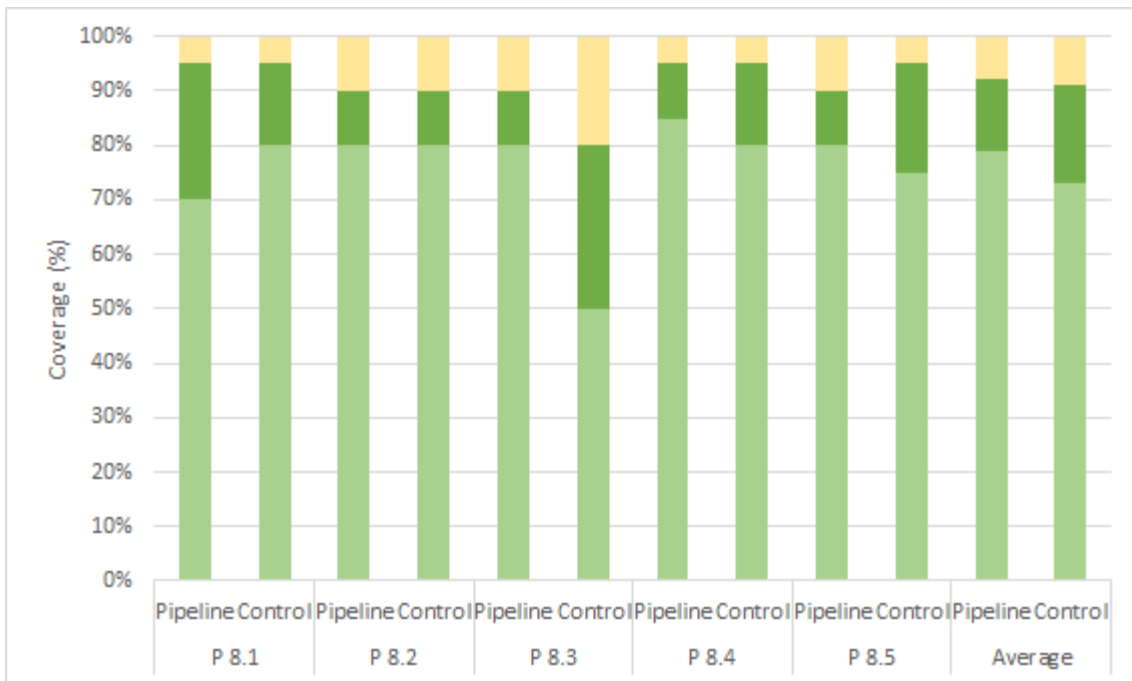
FIGURE 38 - SOIL COVERAGE (IN PERCENTAGE) IN THE 5 MONITORING PLOTS IN SITE 8. ■ HERBS, ■ SCRUBS, ■ BARE SOIL.

In these site all the plots were successfully sampled during field work. A total of 28 plant species were identified in the 10 sampled plots. Figure 38 shows that the coverage percentage of herbs, scrubs and bare soil is very similar in all the plots, with the exception of control plot in site 8.3, where the percentage of bare soil is 20%, while the other plots does not exceed 10%. In average pipeline and control plots are very alike, although in control plots the percentage of scrubs is slightly higher (Figure 38).

The statics result from PERMANOVA, in which the factor “location” (pipeline vs control) was imposed, indicates that there are no significant differences between plots located in the pipeline area and plots located at control areas ($p(\text{perm})=0,0557 > 0,05$). As so, vegetation in the two

different type of plots is similar in regard to their herb and scrub composition, despite the fact that control plots are mainly occupied by trees and shading effect of high tree cover can affect species composition, constraining the grown of sunlight depending herbs and scrubs. In this specific case, maybe vegetation burn is not as severe as in sites 7, where significant differences between plot have been point out, and vegetation had the change to evolve since the construction of the existing MSP, which occurred some time ago. Also, in this site the construction activities and vegetation removal, has not begun yet. Even so this is a very positive data: since vegetation on pipeline area is able to evolve, despite the presence of cattle and humans.

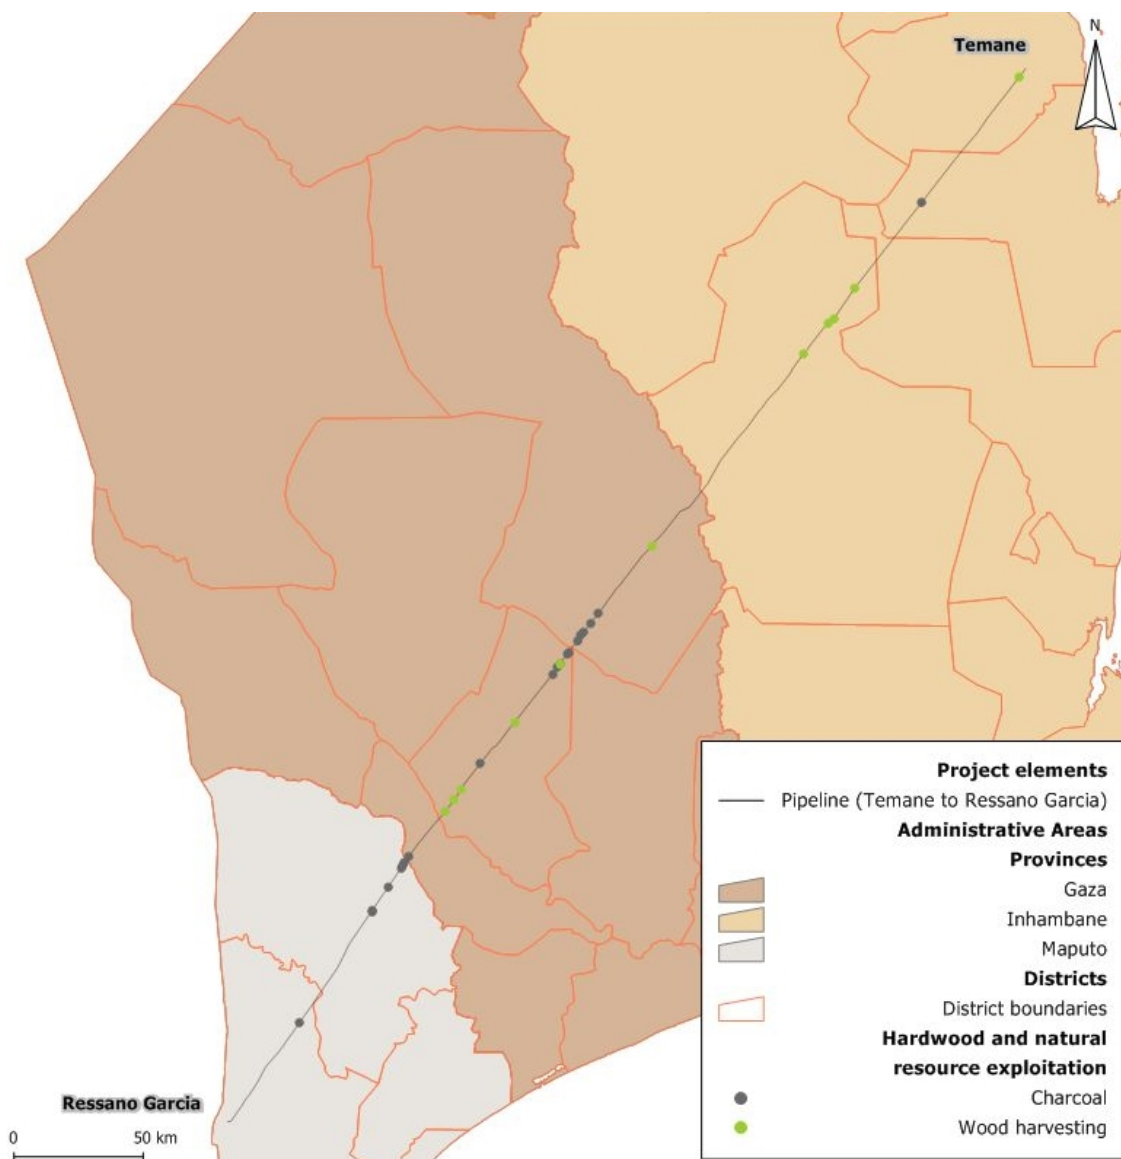
FIGURE 39 – LOCATION OF DIFFERENT NATURAL RESOURCE EXPLOITATION DOCUMENTED DURING FIELD WORK

During the field work natural resource exploitation was registered in 31 different locations. Charcoal exploitation was the most frequent situation, and it was documented in 19 locations (Table 17, Figure 39 and Figure 40). Wood harvesting and pole cuts were also seen along the pipeline, and were documented in 12 different situations (Table 17, Figure 39 and Figure 41).

No chopped up trees were seen and wood logs were not detected along the pipeline. As so, signs of timber industry activities were not perceived. All logging appeared to be for personal use of the population and not for the timber industry.

According to Deacon (2012), natural resources exploitation seemed to be decreasing in 2011, compared to the situation observed in 2008 and 2009 (Table 18). In 2016, charcoal exploitation appears to have increased, while the use of wood cutting and continues to decrease. However, this data should be analyzed carefully as the collected information is a small sample of the reality, since it only reflects the situations observed in only one pass through the project area, providing a picture of a given time. Thus, small variations in the observed numbers may not reflect the reality of the situation, since they are the reflection of the activities that were being carried out on a certain day at a certain place. It should also be noted that this monitoring only contemplates pipeline servitude and no data on what happens around the project has been registered. Thus, the situation on surrounding area is unknown, such as impacts in areas that are now accessible from the ROW and/or the new existing paths and roads linked with the ROW.

- Perform studies to assess the extension of natural resources exploitation in the surrounding area, to confirm which are the most affected areas and species, establishing the baseline situation nowadays and accessing the expected evolution;
- Only after that characterization will be possible to assess the real impact and define the most adjusted measures to mitigate those impacts. One possibility may be the plantation of the most affected species in specific areas, in order to offset the losses caused by increased accessibilities. However, only with the suprarrefered specific studies will be possible to propose additional mitigation measures.
